Geological And Geotechnical Investigations Of Axum Dam Site, Tigray, Northern Ethiopia

Abstract: Geological and geotechnical study was conducted in concrete gravity dam which is planned to be constructed in the Maychew River 40 km south of Axum town for the purpose of water supply for the town. The objectives of this research were: to map geology of the area, to characterize geological defects within and around dam site, to evaluate the water tightness of the dam site, and to determine the bearing capacity of the dam foundation. The research involved: review of different literatures, lithological and structural mapping, characterizing rock masses by using different rock mass classification methods, interpretation of subsurface data (geophysical, core drilled data, test pit data etc.). Results of the study indicate that the area is underlain by Quaternary sediments, metasedimentary and metavolcanic rocks. The Quaternary sediments are characterized by low permeability, low plasticity and are poorly graded nature. Metasedimentary rocks are found covering the right abutment of the dam whereas at reservoir area it is found intercalating with metavolcanic rocks. These rocks are moderate

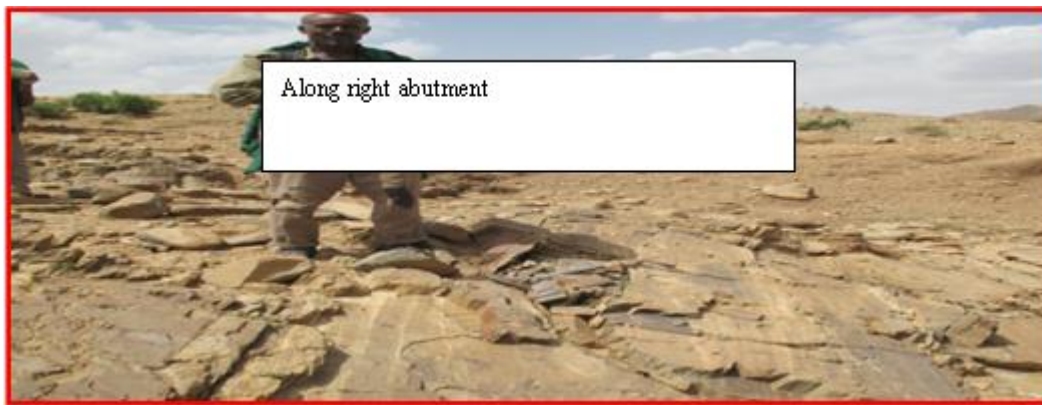
Figure 2.1 *Phyllite/slate along the right abutment*

These phyllite and slate are more prominent in western side of the reservoir area and right abutment of the proposed dam foundation. Megascopically the rocks are fine-grained and show well developed foliation in phyllite and slaty cleavage in slate (Figure 2.1). These rocks are characterized by different types of local folds, relicts of sedimentary beddings, highly weathered and show a range of colours such as light grey, dark grey and green. The top highly weathered rock is filled by clay leachates and expected to have low permeability but the underlying materials have foliations and open joints parallel to the river direction and can have adverse effects on leakages of the expected reservoir water. In the phyllite and slate units there are quartz veins widespread in the right abutment of the study area. They occur along shear zones and other discontinuities. These quartz veins are commonly metamorphic upset and occur almost in all metamorphic rocks mapped in the study area.

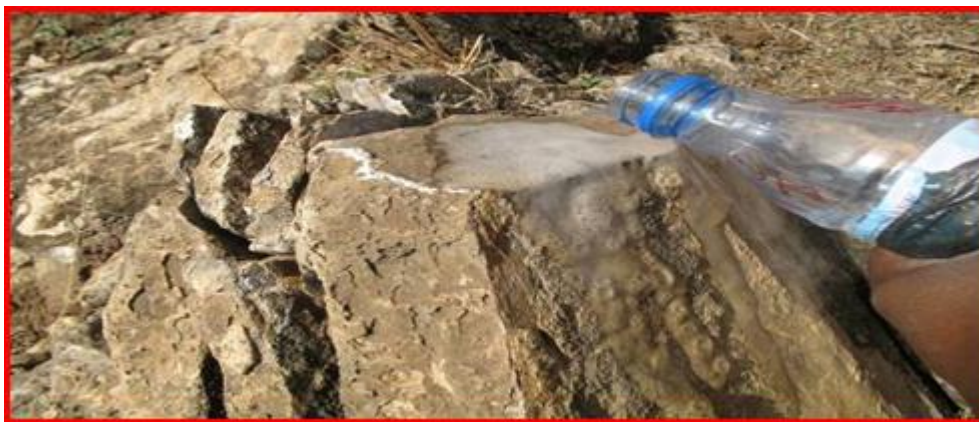
Figure 2.2: *Limestone unit from right abutment*

The black limestone is black in color and the weathered part is grayish in colour (Figure 2.1). It outcrops within the dam reservoir area and at the top of right abutment, as two layers of narrow ridge forming unit. These two layers of black limestone rocks are developed between other metasediment rocks (e.g. slate and phyllite). They are almost parallel to each other and their alignment is north-east and south-west strike; and the distance between two layers is wider towards the right abutment. The one which found in the right or down side ridge(block) forming black limestone layer of the

measured thickness about 4 to 10 m and at one point it's bulged maximum 18 m in thickness. This layer is grayish black in color and sometimes pink, interbedded with clay component. The one in the left side block forming black limestone layer is thicker than right one and its thickness is 15 to 20 m. At the bottom of this layer there is lenticular quartzites are intermittently occurred and 10 to 20 m in length and 0.5 to 1 m in thickness. These two black limestone layers form small ridges in the top and back of the right abutment ridges of the dam foundation (Figure 2.1).

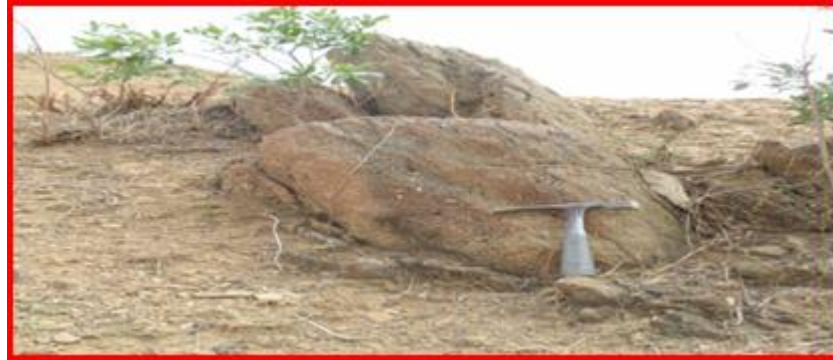
Figure 2.3: Metagreywacke in the northwestern area

arkosic. So, this rock is a weakly metamorphosed greywacke to the lower parts of greenschist facies. Weathering is the main factor that weakens the greywacke. The thickness of the highly weathered closely jointed sandstone measured from borehole 8 is about 2-4 meters. The weathering of the greywackes decreases gradually and progressively with increasing depth.

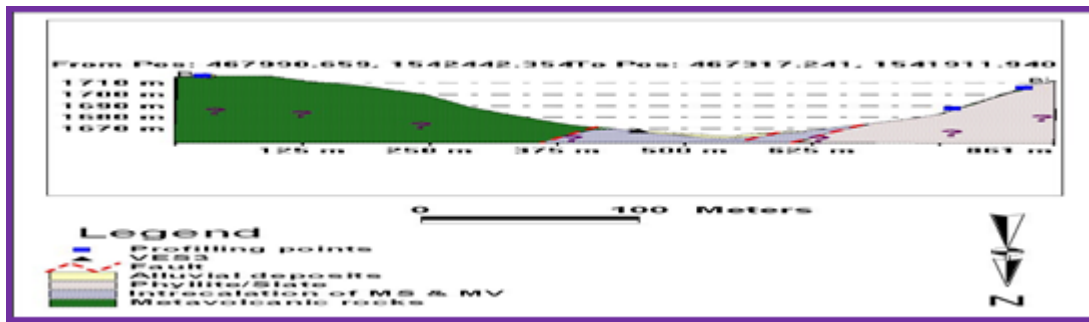
Figure 2.4: Geological map of Axum dam site and cross section along B-B'

The alluvial deposits are found along the banks and bed of the prevailing Maychew River. It is a thin layer where the depth decrease as one ascends on both sides of the banks. The depth adjacent to the river is 3-4m and these soils are composed of clayey-silt, sand, gravel and cobble. The gravels and cobbles are mostly derived from basalt, sandstone and metavolcanics. Their source is from upstream including Axum town and nearby catchments. The upper parts of alluvial deposit more dominated by clayey-silt and at bottom are dominated by sand, gravel and cobbles.

As described in chapter two, in addition to colluvial-alluvial deposits, the typical lithological units that make up geology of the area are: metasediment and metavolcanic rocks. As can be noted from the geological map of the area (Figure 2.4) there is surficial lithological variations along the dam axis and different geological defects were found in the dam foundation and reservoir area. However, to confirm the above mentioned variability subsurface geological and geotechnical investigations were carried out. Data from, borehole logging, packer testes, geophysical resistivity imaging and vertical electrical sounding, and different laboratory geotechnical data were used to interpret the subsurface geological conditions.

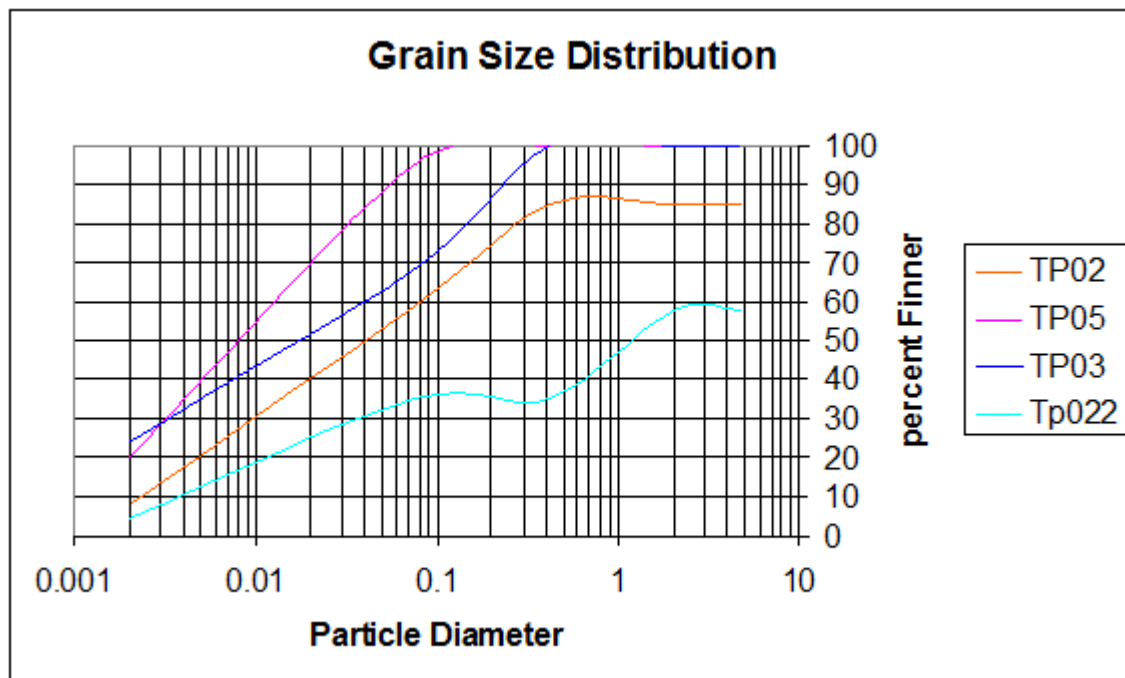
Figure 3.1: Grain size distribution

The particle size analyses for the samples from clay borrow area, sand borrows, and near to foundation area was analysed as follows. The dominant grain size by percentage passed is silt; therefore most of the result shows that soil is silty-clay and some of them also silty-sand. The grain size distribution (Figure 3.1) of the soil particles shows that the soil in study area contains from fine material to coarse materials. The soil is named as poorly sorted or well graded. Due to poorly sorted and fine dominated behavior of soil, the permeability of the soil in the study area is very low as shown in (Table 16). As can be observed from Figure 3.1, the representative soils are non uniform.

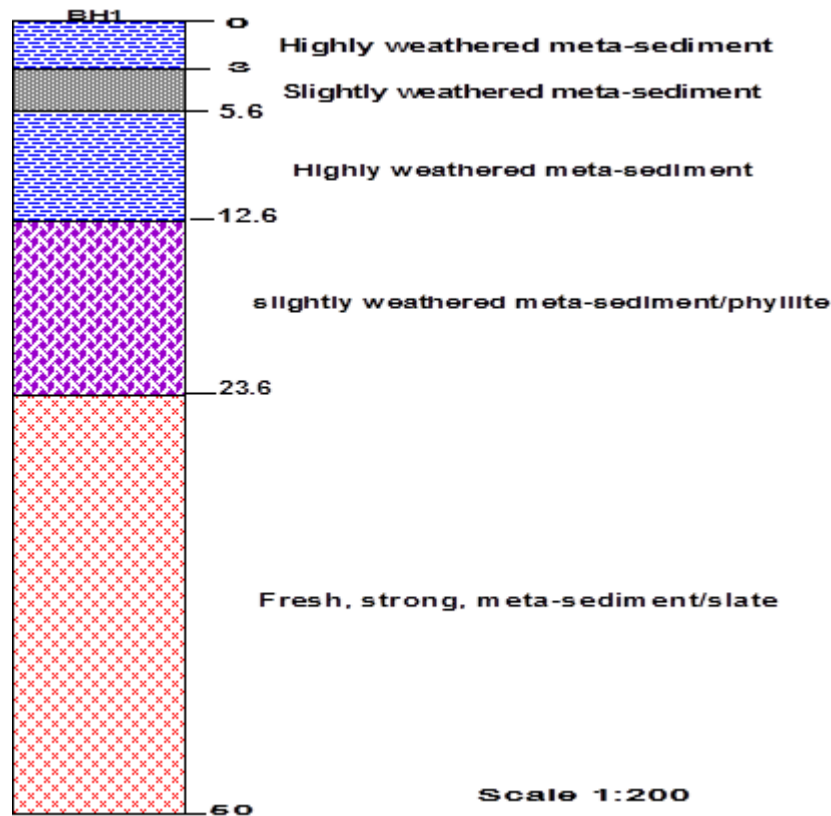
Figure 3.2. Core log from borehole one, (MA-BH1)
(Note: Log depth measured in metre)

be noted from Table 5, boreholes MA-BH3 and MA-BH4 were drilled at dam foundation, whereas MA-BH1, MA-BH2, MA-BH5 and MA-BH7 were drilled on the abutments. A total depth of 196.5m was drilled. The total depth of MA-BH1 is about 50m (log is shown in Figure 3.2) and was drilled at the right abutment. The core samples of these boreholes show that at shallow depth discontinuities are filled by fine grained soils but at depth (beyond 25m) almost all discontinuities are filled with calcite minerals In addition to core logging about 36 Lugeon tests were conducted in conjunction with the drilling. The core logging information from exploratory drilling works includes depth to bedrock and groundwater Table, lithology, color, and degree of weathering, discontinuity conditions, total core recovery (TCR), rock quality designation (RQD) and bedding. Detailed information on core descriptions is presented in Tables 5.

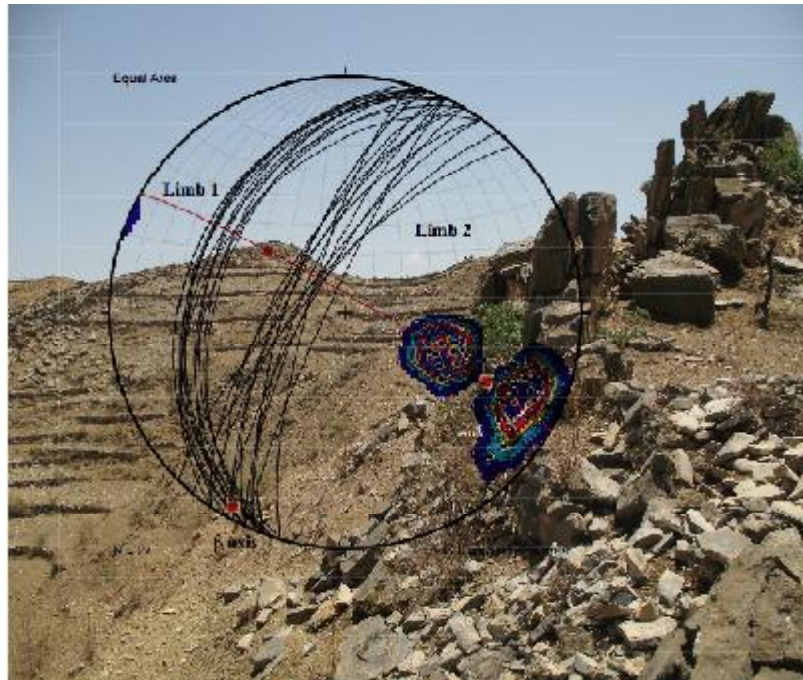
Figure 3.3: Orientations of fold limbs

The most willingly obvious influence of the orientation of discontinuities on rock mass strength is noticeable in the failure of rock slopes along one or more discontinuities [58]. During discontinuity surveying, this research work mostly focusing the steepness of discontinuities and how they intercept the existing slope (i.e. include dip and strike). However, in the following Tables 8 and 9 the dip direction of discontinuities is opposite to slope face. This confirms that

there is almost no slope problem in the study area at right abutment but in left abutment generally the slope is gentle and there is no exposed slope faces. But the main potential problems related to orientation of discontinuities around right abutment are seepage/leakage. Because there is another valley beyond the right abutment and most of those discontinuities dipping towards this valley, specially bedding partitions outcrop in the next valley.

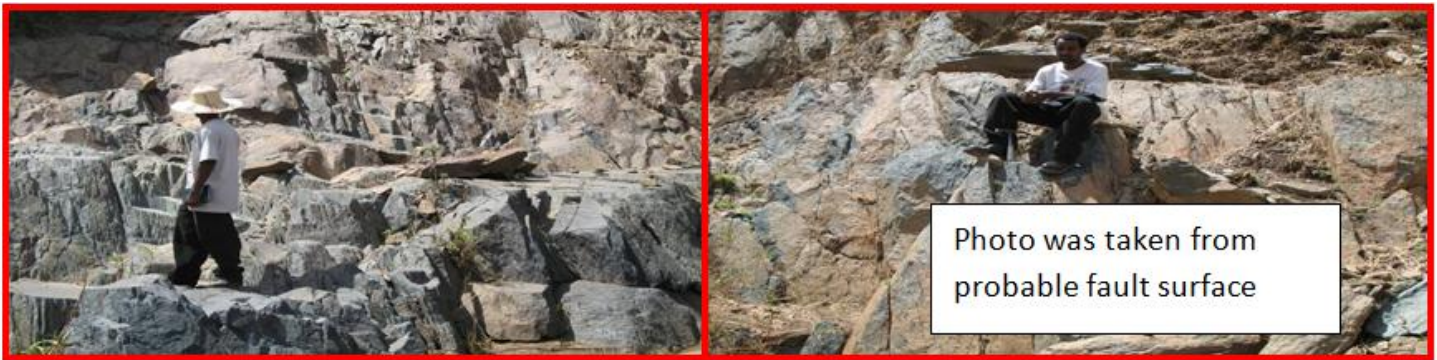
Figure 3.4: Some kinematic indicators and steps on the proposed fault surface.

During field work fracture surface irregularities were considered as one factor. As identified in the field the discontinuity surfaces characterized as wavy or undulating, rough and the side of wall conditions. Fracture surface roughness is a measure of the inherent surface unevenness and waviness of the discontinuity relative to its mean plane. The roughness of discontinuities of the dam site is characterized by small scale waviness and large scale unevenness of a discontinuity. It is the principal governing factor the direction of shear displacement and shear strength. Roughnesses also distinguished in north-western part of the study area are small scale surface irregularity or unevenness and large scale undulation or waviness of the discontinuity surface.

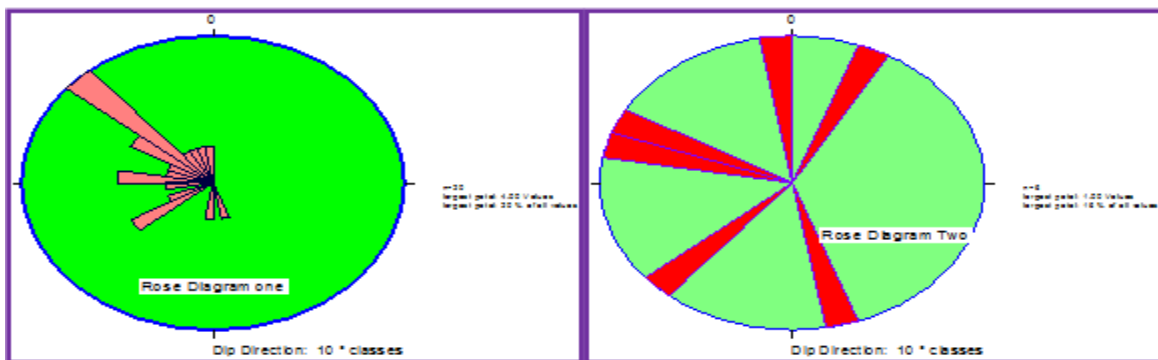
Figure 3.5: Orientation of fractures (rose diagram one-from right abutment and two from left abutment)

Type	Dip/ Dip direction	Spacing (cm)	Aperture (mm)	Infill
Joint	82/220	100-120	0.2-0.8	Open
Fault	19/280	-	-	Open
Joint	60/020	80-140	0.1-0.31	Open
Joint	80/160	60-70	0.22-0.9	Open
Joint	40/290	70-130	Tight	Clay
Joint	80/350	60-90	Tight	Open

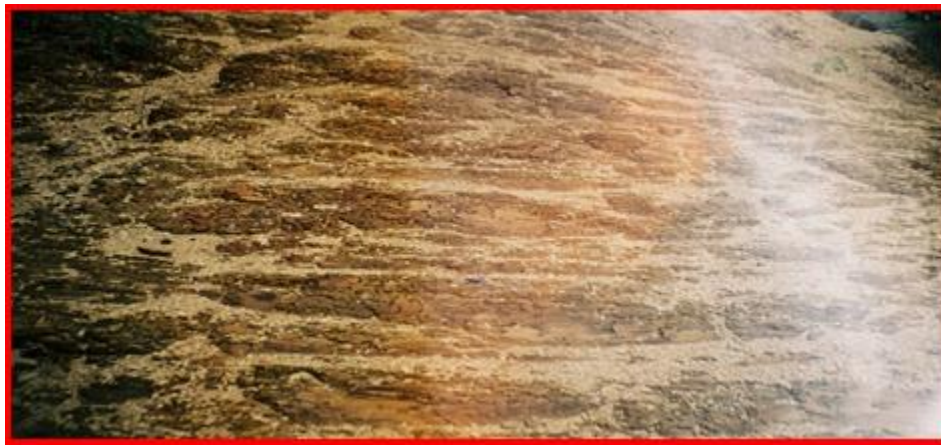
Figure 3.6: Weathered phyllite and slate

The weathering of the metamorphic rock has resulted in formation of a crust of weathering, the thickness of which is negligible at the river bed and thickness increases towards the upper elevations of the banks. In the dam foundation, the gorge slopes are composed of talus and alluvial

deposits having a maximum total thickness about 5 m. These deposits are characterized by low shear strength and permeability. The river channel section is composed of slightly jointed hard rock. In the upper part of the river bank the thickness of the highly weathered rock reaches 4-6 m.

Weathering is exceptionally deep under the left bank ridge of the right abutment of the dam, especially in the phyllite and slate bed. The bedrock of this part is distorted and sheared by faults, through which calcite and quartz intrusion has developed in to the bedrock. The depth of weathering depends on the composition and degree of fissuring of bedrock. Along faults in rocks which are more susceptible to weathering, the penetration of weathering reached more than 23.6 m (BH1). This deep weathering is common along the bands of limestone and phyllite/slate. The limestones within the zone of weathering are subjected to karstification. In the weathering profile the following sequence of layers has been identified from core log; (from top to bottom):

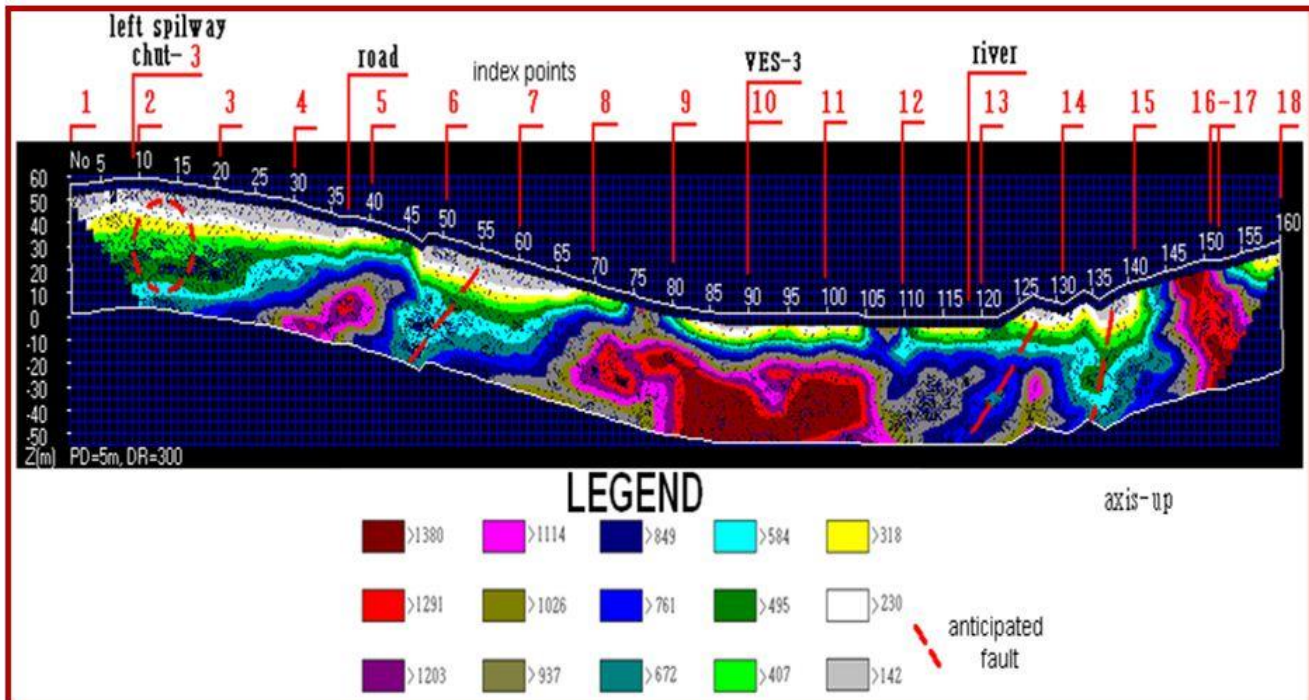
Figure 3.10: Apparent resistivity profile of upstream of the dam axis

shattering of the basement is likely to the intrusive body between the index points 4 and 5.5. There also exist three geological structures around index point 6, 14 and 15. The thickness of top soil is 12 m between index point 1 and 4, and about 6 m around index point 6, 14 and 15.

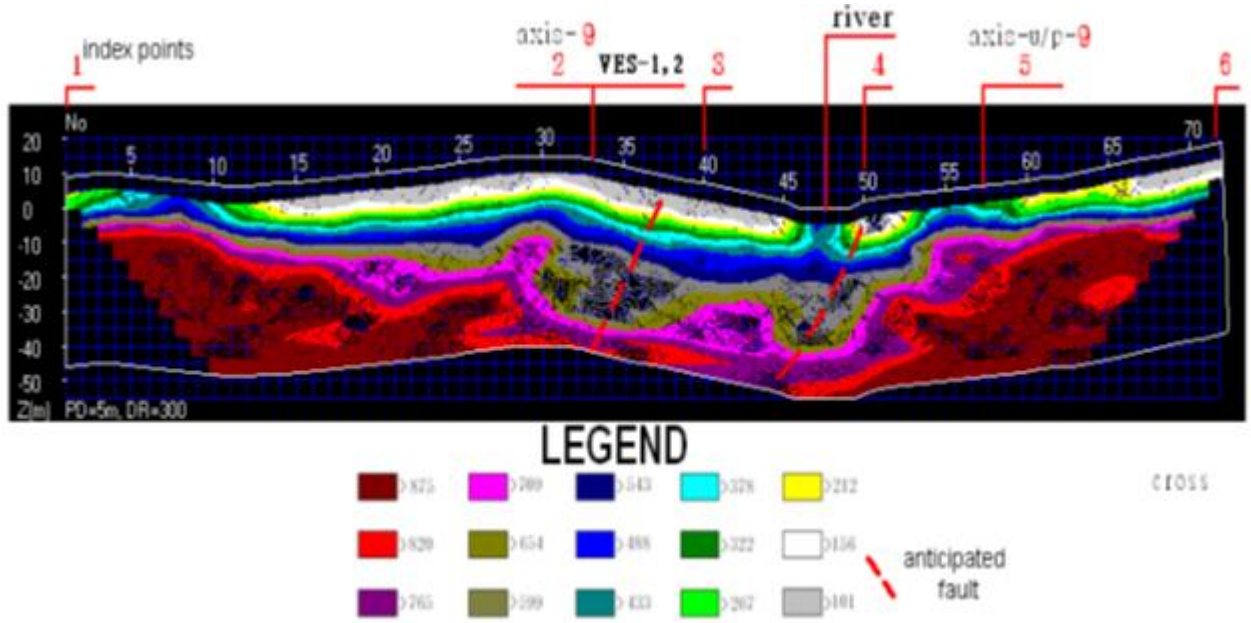
Figure 3.11: Apparent resistivity profile of cross line of dam axis

The following geoelectrical cross section indicates that at the right abutment area there is deep weathered rock. This

cross section was taken from with some angle deviation across dam axis.

The cross line intersects Dam axis line at the index point 2 (index point 9 of Dam axis line) and upstream line at the index point 5 (index point 9 of upstream).As can be noted from Figure 3.11, there exist two geological structures between index point 2 and 3, and around index point 4. A geological structure between index point 2 and 3. The thickness of top soil is 3 to 5 m around index point 2.

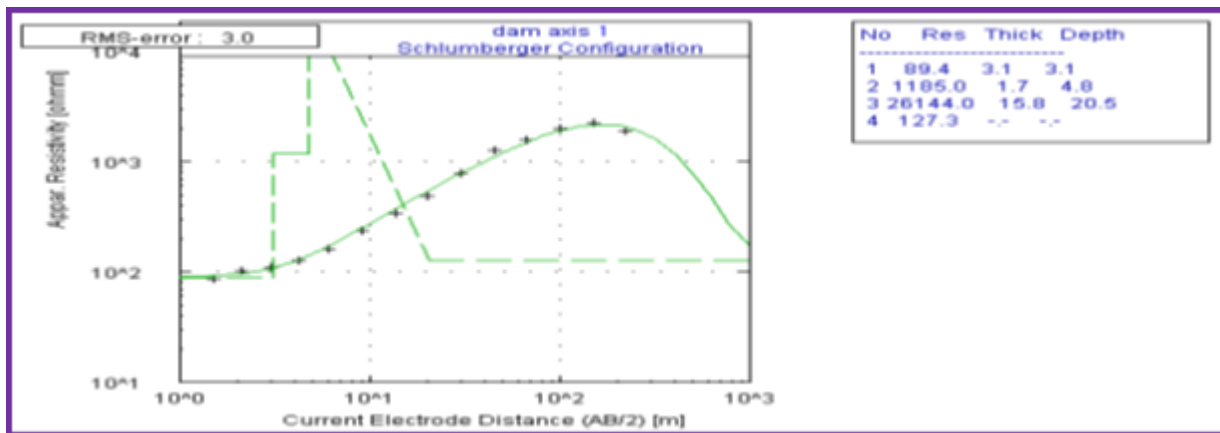
Figure 3.13: VES #1, Dam site (data source: WWDSE, 2009).

- a) VES #1: as can be observed from the one dimensional model curve indicated in Figure 5.13.
 - The upper 3.1m is considered as soil and below the soil about 1.7m weathered and fractured bedrock.
 - From 4.8 to 20.5m is strong and slightly jointed basement rock.
 - The low resistivity value below depth of 20.5m is believed to be due to fault zone.

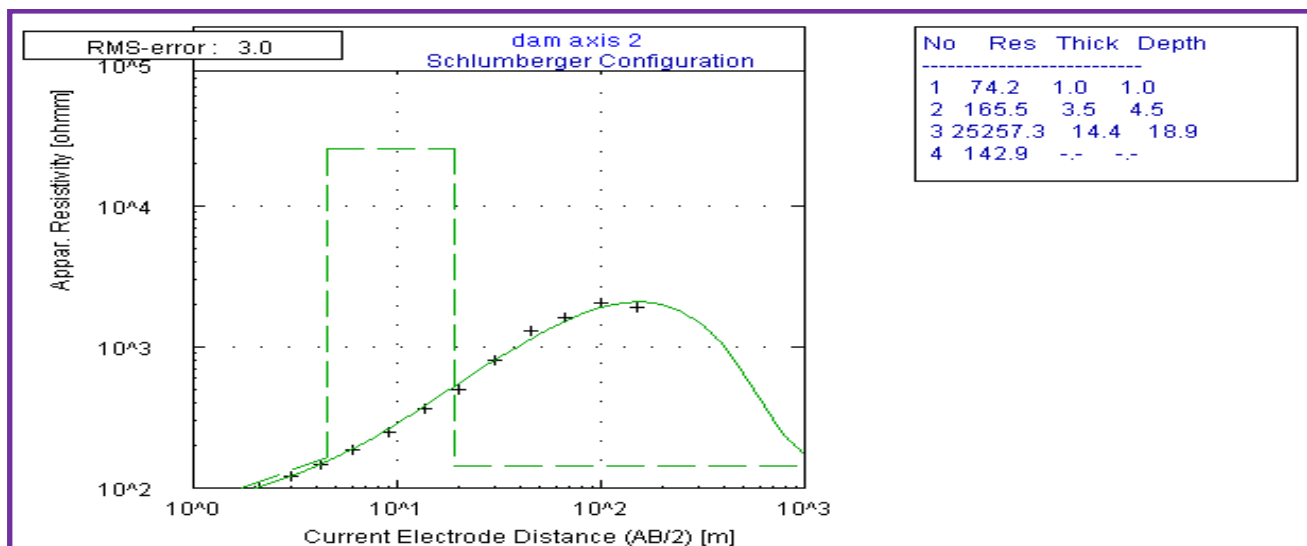
Figure 3.14 VES #2, Dam site, Maychew (data source: WWDSE, 2009)

- b) VES#2: it was taken across the dam axis. The one dimensional model curve (Figure 3.14) shows that:
 - Upper 1m is colluvial soil.
 - Closely jointed and highly weathered metasediment underlain the soils (thickness up to 3.5m).
 - From 3.5-14.4m is massive metasediment.

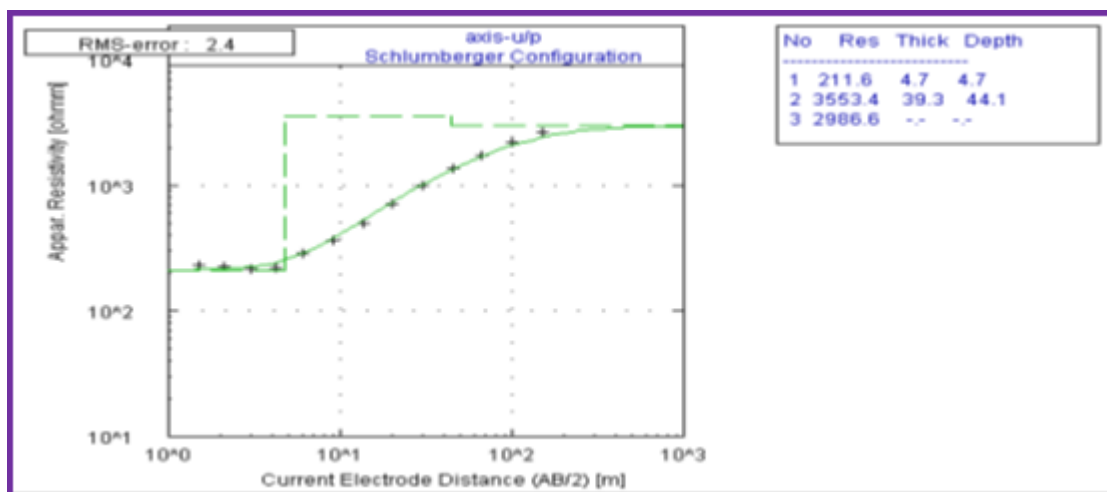
Figure 3.15: VES #3, upstream line of Dam, Maychew (data source: WWDSE, 2009).

- c) VES #3 it was taken from upstream of the dam axis. The one dimensional model curve (Figure 3.15) show that:
- The top layer 4.7 m is highly fractured and weathered meta-sediment.
 - The resistivity rapidly increasing up to depth of 44.1m reveals the massive/sound rock

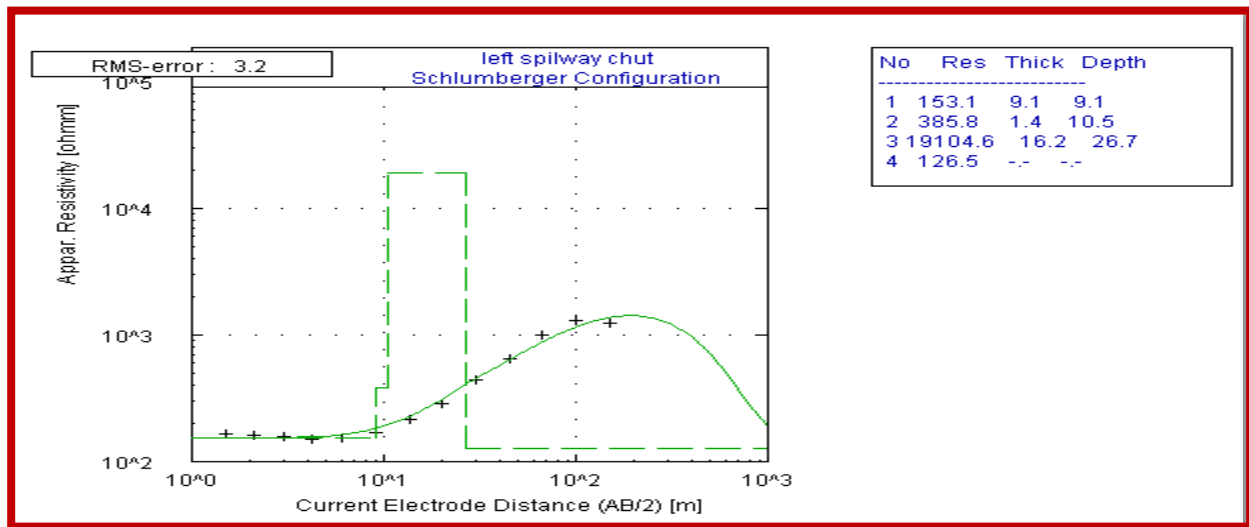
Figure 3.16: VES #4, left abutment (data source: WWDSE, 2009)

- d) VES #4: as can be observed from the one dimensional model curve indicated in Figure 3.16
- The upper 9.1m is weathered and highly jointed rock.
 - From 9.1m to 26.7m is strong and slightly fractured rock.
 - Highly fractured zone is expected below 26.7m.

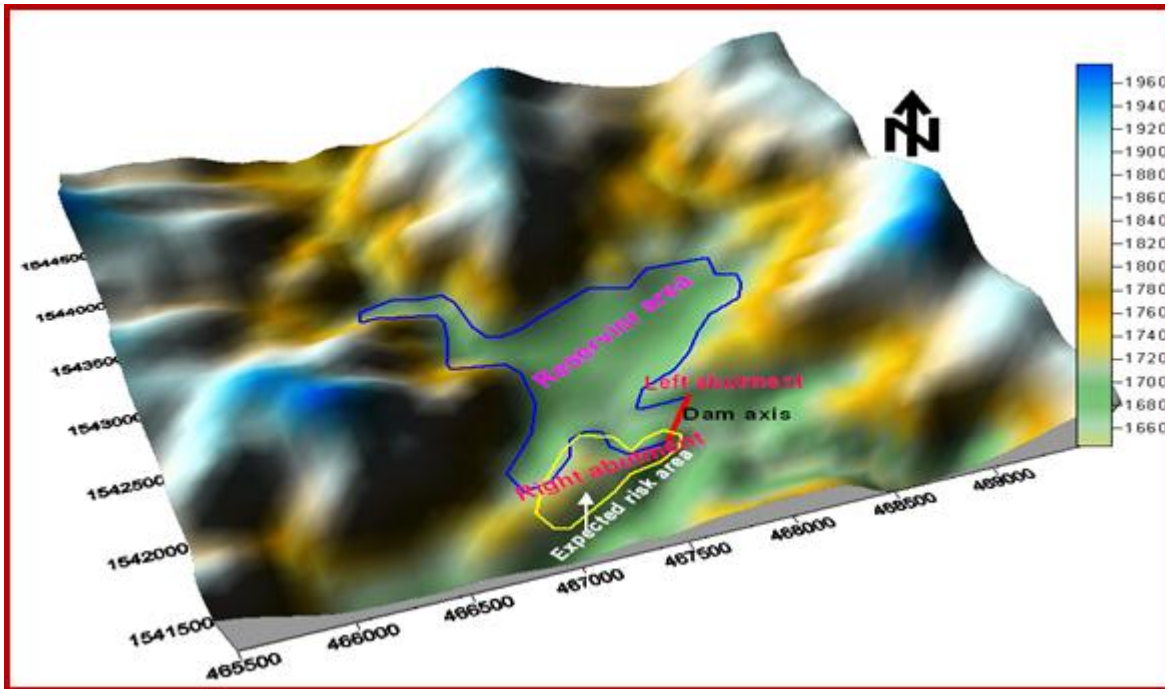
Figure 3.23: Risk area for seepage.

- As geological section map of the dam foundation shown (Figure 3.17) that the groundwater level from right side of central valley is very deeper than the left side. It is filled with water and the gradient of water inclined outward from reservoir.
- The dip direction of metasediments that occur at the right abutment is outward from the reservoir. As a result potential seepage/leakage problem could be expected.
- There are deep-seated weak zones (faults, joints, beddings, intensely weathered zones etc) within the bedrock of the right abutment and along the main river channel which could cause potential seepage/leakage problems.
- The presence of rocks with different modulus of deformation along the dam axis 26.6GPa at left and 8.9GPa at right indicate that there might be differential settlement which needs to be causes in the design.

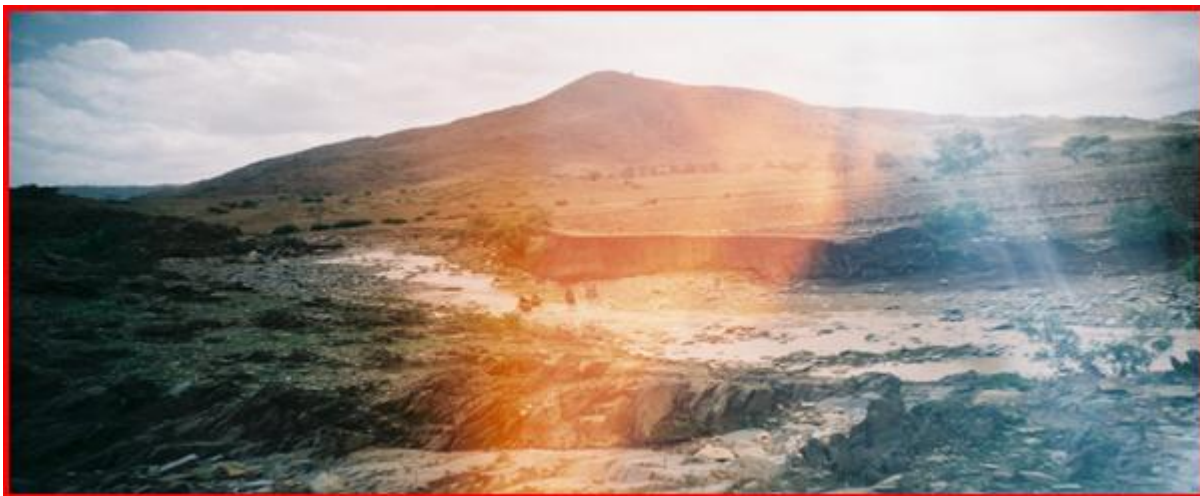
Figure 3.24: The area where traditional gold Mining taking place around the river.

- Initiate slope instability problems around the proposed dam site.
- The residue of ore or tailings may pollute the quality of water.
